Manhole Inspection Summary

Manhole # S55K__055MH

Insp Date: **6/2/08 10:19 AM**

Location Address: **3710 foster ave**

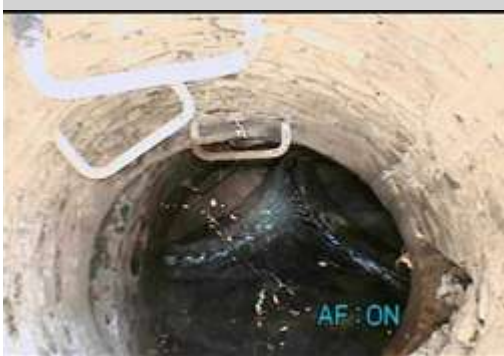
Defect 3

debris

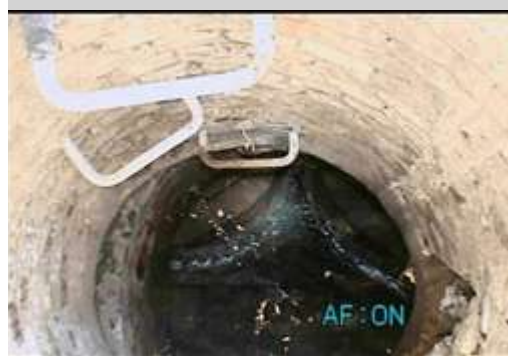
Defect 2

Steps Count: **5** Missing: **0** ☒ **Corroded**

hole in corbel and corroded steps

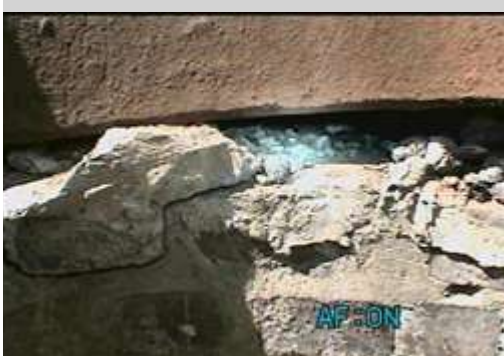
Defect 1

Condition: ☐ Sound ☒ **Cracked** ☐ Root Intrusion ☒ **Loose Brick** ☒ **Deteriorated**

corbel loose bricks,deteriorated,

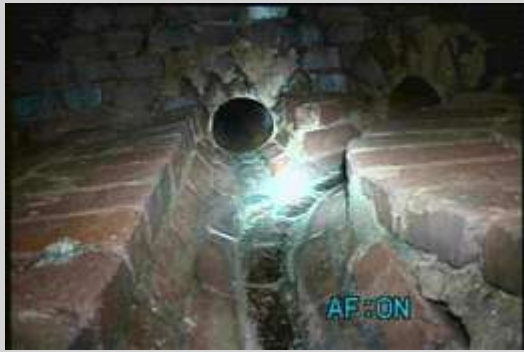
4 O'Clock Inflow

Best view, Pipe in @ 4 is on the right of this image, under shelf
